**Flood Control Project Maintenance
Levee Inspections**

Fall 2019 Levee Maintenance Deficiency Summary Report

Sacramento River Basin

NA0003	Overall LMA Rating	Total LMA Miles						
Butte County Department of Public Works	A	23.78						
Rated Item	Maintenance Deficiency				Enforcement		Design & System Obsolescence	
	M Miles	U Miles	M + 4U Miles	Threshold %	M Miles	U Miles	M Miles	U Miles
<i>Earthen Levee</i>								
Vegetation	0.35		0.35	1.47%	0.03	0.23		
Trim / Thin Trees	0.15		0.15	0.63%				
Encroachments	0.03		0.03	0.13%	2.61	0.48		
Animal Control	0.03		0.03	0.13%				
Slope Stability	0.10		0.10	0.42%				
Erosion / Bank Caving	0.01		0.01	0.04%				
<i>Supplemental</i>								
DRAFT DWR UCIP Field Study					0.10			
DRAFT DWR UCIP LMA Responsibility								
<i>LMA Totals:</i>	0.67	0.00	0.67	2.82%	2.74	0.71	0.00	0.00

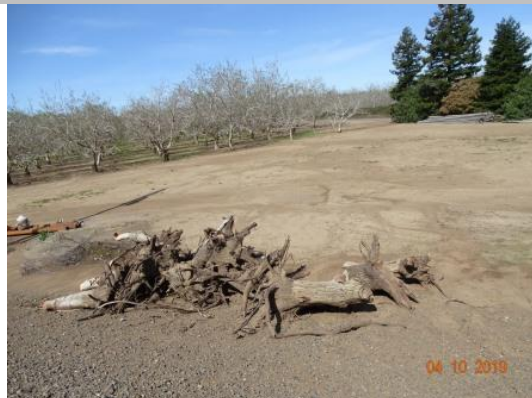
Photo 1 of 1 : FA_2019_NA0003_64_26_20190822_00007.jpg

LM Start	0.19	Rating **	M	Issue No.	26
LM End	0.19	Issue Type +	En	Location *	LS
Category	Earthen Levee			GPS Latitude/Longitude	
				Start	End
Item	Encroachments			39.728529 °	39.728529 °
				-121.934012 °	-121.934012 °
DWR ID	DWR_NA0003_01_s_2019_26				
Comment Code					
PR : Prunings					
Inspector Comment					
The piles of prunings and tree stumps should be removed from the landside toe.

View of an adjacent pile of tree stumps at the landside toe. Spring 2019.

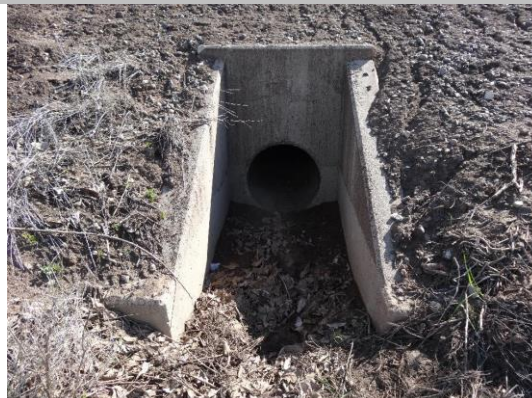
Photo 2 of 3 : UCIP_FA_2019_29705_54923.jpg

LS view: U typed concrete headwall, CMP on levee slope.

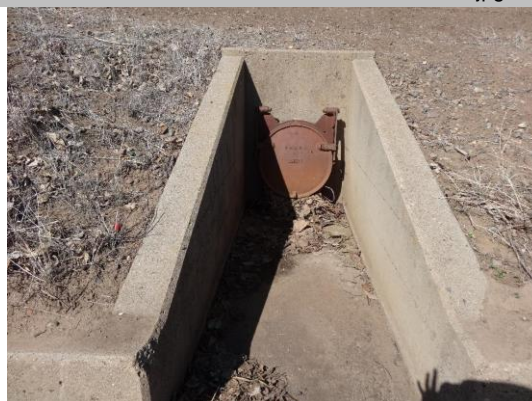
Photo 1 of 3 : UCIP_FA_2019_32044_58543.jpg

WS view: U typed concrete headwall, pipe, and flapgate on levee slope.

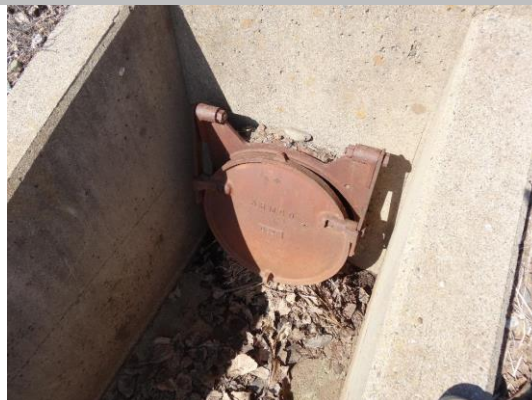
Photo 2 of 3 : UCIP_FA_2019_32044_58542.jpg

WS view: vegetation debris blocking outlet.

Comment Code						
Inspector Comment						
DS_ID:19211						
FS_ID:32044						
EP_NO: N/A						
Repair Type: Non-Urgent						
Crossing Status: Found						
UCIP Comments: Vegetation debris on waterside. Needs clearing and cleaning.						
FIELD_STRUCT_DESC: 24-inch corrugated metal gravity drainage pipe through the levee, 12 feet below the crown. Flap gate on the waterside (WS) end. Concrete U-shaped headwall on each end. Grouted riprap apron on the landside (LS) end. Grouted riprap spillway on the WS end. [Additional Reference(s): DWR Levee Log, 1992. USACE Sacramento O&M Manual 504, May 1965, (HLM 1.03)].						
FS Date: 2/20/2014

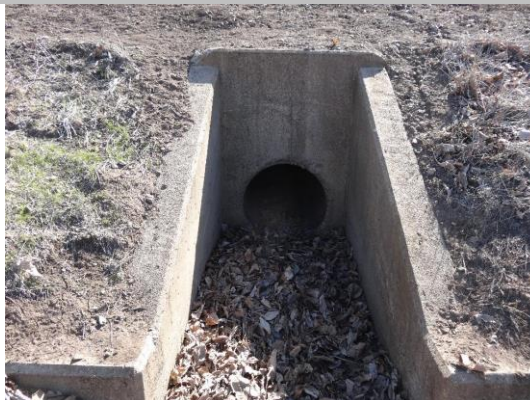
Photo 3 of 3 : UCIP_FA_2019_32044_58541.jpg

LS view: U typed concrete headwall and CMP on levee slope.

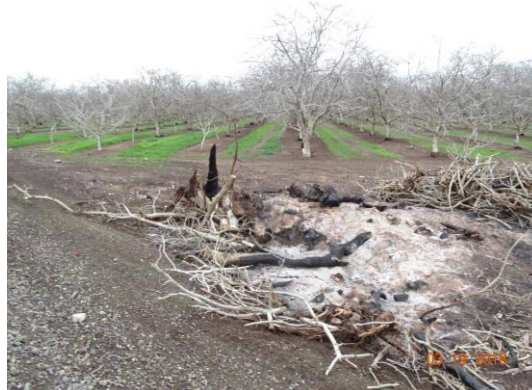
Photo 1 of 1 : FA_2019_NA0003_64_15_20190822_00002.jpg

LM Start	1.69	Rating **	M	Issue No.	15
LM End	1.69	Issue Type +	En	Location *	LS
Category	Earthen Levee			GPS Latitude/Longitude	
				Start	End
Item	Encroachments			39.745718 °	39.745718 °
				-121.923124 °	-121.923124 °
DWR ID	DWR_NA0003_01_s_2014_15				
Comment Code					
PR : Prunings					
Inspector Comment					
The prunings should be removed from the landside toe.

View of the prunings along the landside toe.

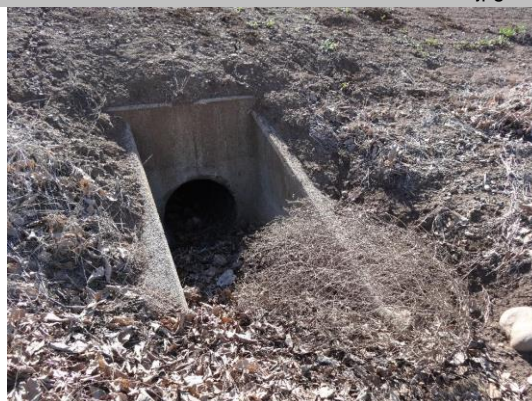
Photo 2 of 3 : UCIP_FA_2019_50142_55885.jpg

Comment Code						
Inspector Comment						
DS_ID:19212 FS_ID:50142 EP_NO: N/A Repair Type: No Action Needed Crossing Status: Found UCIP Comments: 08/29/2016: Shawn Bates of NA0003 has cleared the LS and WS of debris and blockage; WS gate functions properly now. Crossing has been downgraded from Urgent to No Action Needed. (K. Fazel - UCIP)08/11/2016: Same as last inspection. (K. Fazel - UCIP)02/20/2014:No riprap spillway on waterside. Needs cleaning and clearing of debris. Flap gate was not fully closed. (P. Amatya - UCIP) FIELD_STRUCT_DESC: 24-inch corrugated metal gravity drainage pipe through the levee, 13 feet below the crown. Flap gate on the waterside (WS) end. Concrete U-shaped headwall on each end. Grouted riprap apron on the landside (LS) end. Grouted riprap spillway on the WS end. [Additional Reference(s): DWR Levee Log, 2005. USACE Sacramento O&M Manual 504, May 1965, (HLM 1.95)]. FS Date: 8/11/2016

LS view: U type concrete headwall and CMP on levee slope. Vegetation debris blocking inlet.

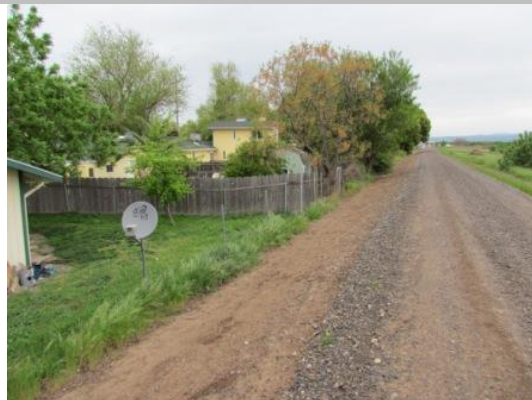
Photo 1 of 1 : FA_2019_NA0003_64_3_20190822_00001.jpg

LM Start	2.00	Rating **	M	Issue No.	3
LM End	2.04	Issue Type +	En	Location *	LS
Category	Earthen Levee			GPS Latitude/Longitude	
				Start	End
Item	Encroachments			39.748330 °	39.748867 °
				-121.918685 °	-121.918533 °
DWR ID	DWR_NA0003_01_s_2012_3				
Comment Code					
FE : Fence					
Inspector Comment

View of the fences along the landside toe.

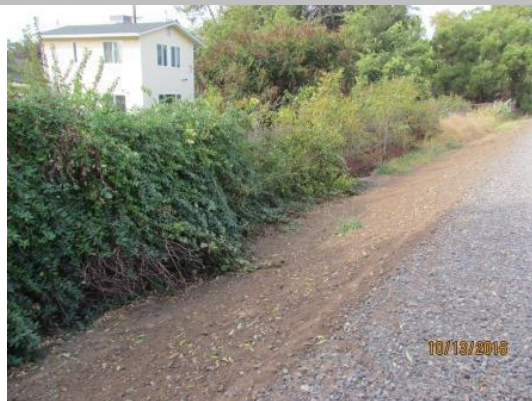
Photo 1 of 1 : FA_2019_NA0003_64_48_20190822_00020.jpg

LM Start	2.03	Rating **	U	Issue No.	48
LM End	2.11	Issue Type +	En	Location *	LS
Category	Earthen Levee			GPS Latitude/Longitude	
				Start	End
Item	Vegetation			39.748784 °	39.749872 °
				-121.918597 °	-121.918296 °
DWR ID	DWR_NA0003_01_f_2016_48				
Comment Code					
V6 : Landscaping					
Inspector Comment

View of landscaping vegetation blocking visibility.

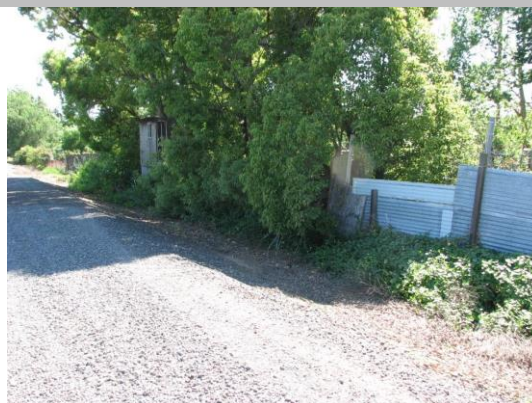
Photo 1 of 1 : FA_2019_NA0003_64_40_20190822_00018.jpg

LM Start	2.06	Rating **	U	Issue No.	40
LM End	2.08	Issue Type +	En	Location *	LS
Category	Earthen Levee			GPS Latitude/Longitude	
				Start	End
Item	Encroachments			39.749145 °	39.749461 °
				-121.918506 °	-121.918425 °
DWR ID	DWR_NA0003_01_s_2016_40				
Comment Code					
FE : Fence					
Inspector Comment					
The corrugated fencing with vegetation is completely obscuring landside toe.

View of a metal fence and treehouse obstructing visibility and access.

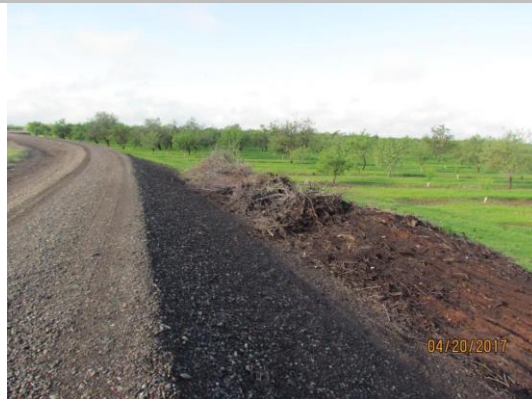
Photo 1 of 2 : FA_2019_NA0003_64_49_20190822_00021.jpg

LM Start	2.59	Rating **	M	Issue No.	49
LM End	2.59	Issue Type +	En	Location *	LS
Category	Earthen Levee			GPS Latitude/Longitude	
				Start	End
Item	Encroachments			39.755930 °	39.755930 °
				-121.914829 °	-121.914829 °
DWR ID	DWR_NA0003_01_f_2016_49				
Comment Code					
PR : Prunings					
Inspector Comment					
The prunings should be removed from the landside toe.

View of the prunings along the landside toe.

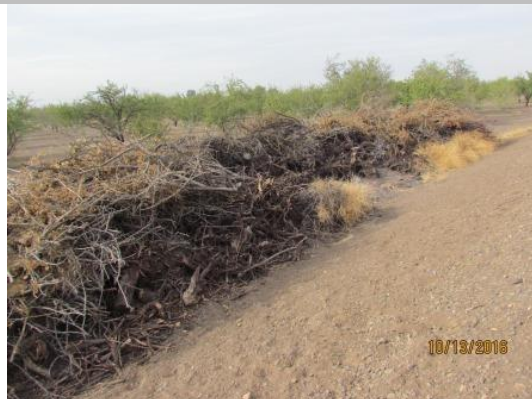
Photo 2 of 2 : FA_2019_NA0003_64_49_20190822_00022.jpg

View of the prunings along the landside toe.

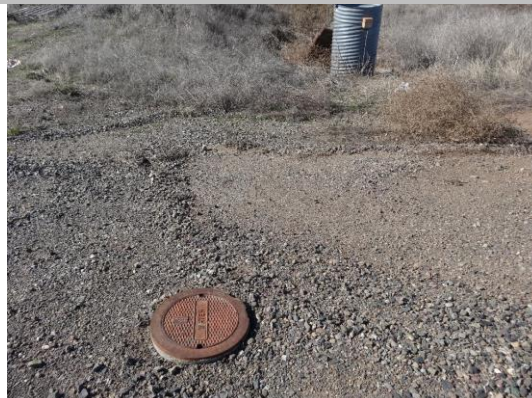
Photo 1 of 3 : UCIP_FA_2019_30291_55700.jpg

DS_ID:19230
FS_ID:30291
EP_NO: 16633
Repair Type: Non-Urgent
Crossing Status: Indicator Found
UCIP Comments: A concrete water control box on landside shoulder. It needs confirmation and more info from LMA and/or DWR Inspector.
FIELD_STRUCT_DESC: 2-inch coated and wrapped steel storm water discharge pipeline through the right bank and landside (LS) levee toe of Mud Creek. Submerged pump in a 36-inch corrugated metal pipe (CMP) casing, approximately 10 feet from the LS toe. Drainage ditch, up to 4 feet wide, runs perpendicular to the levee alignment starting at a CMP riser and running away from the levee. (Plans to install a 2-inch storm water discharge pipe through the levee and a pump on a concrete base on the right bank LS levee toe of Mud Creek authorized under Permit No. 16633, 1996 - Jim Paiva).
FS Date: 2/20/2014

LS view: CMP riser on levee toe (top) and control box on levee shoulder (bottom).

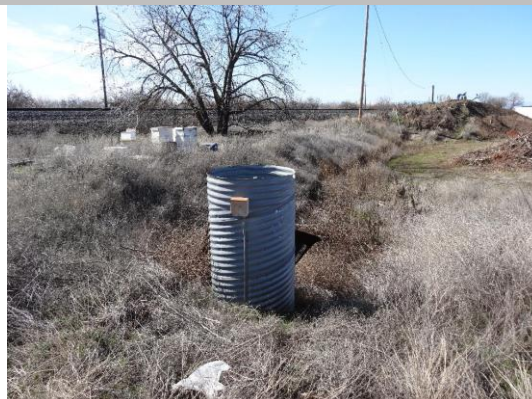
Photo 2 of 3 : UCIP_FA_2019_30291_55699.jpg

LS view: CMP riser on levee toe and drainage ditch perpendicular to the levee.

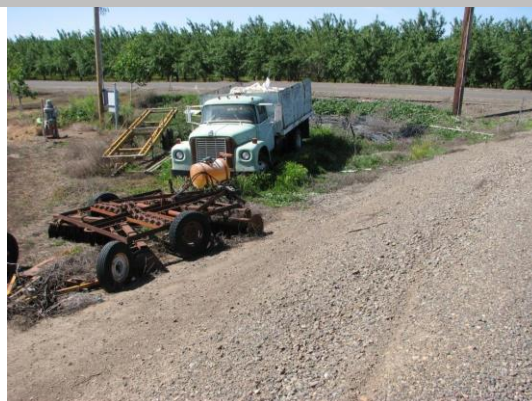
Photo 1 of 1 : FA_2019_NA0003_64_39_20190822_00017.jpg

LM Start	2.98	Rating **	M	Issue No.	39
LM End	2.98	Issue Type +	En	Location *	LS
Category	Earthen Levee			GPS Latitude/Longitude	
				Start	End
Item	Encroachments			39.760539 °	39.760539 °
				-121.911376 °	-121.911376 °
DWR ID	DWR_NA0003_01_s_2016_39				
Comment Code					
AV : Abandoned vehicles					
Inspector Comment					
Truck and farm equipment are blocking the landside toe.

View of equipment and vehicles along the landside toe.

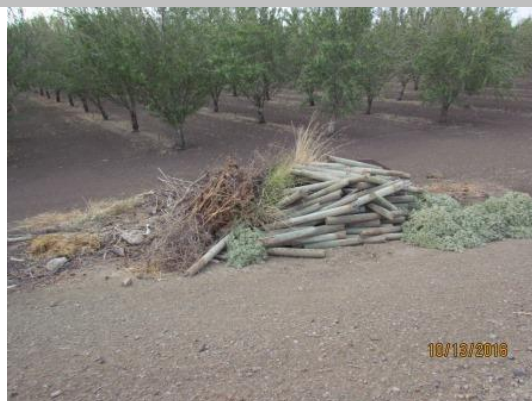
Photo 1 of 1 : FA_2019_NA0003_64_25_20190822_00005.jpg

LM Start	3.02	Rating **	M	Issue No.	25
LM End	3.02	Issue Type +	En	Location *	LS
Category	Earthen Levee			GPS Latitude/Longitude	
				Start	End
Item	Encroachments			39.761085 °	39.761085 °
				-121.911048 °	-121.911048 °
DWR ID	DWR_NA0003_01_s_2012_25				
Comment Code					
PR : Prunings					
Inspector Comment					
The prunings should be removed from the landside slope.

View of the prunings and wooden posts along the landside toe.

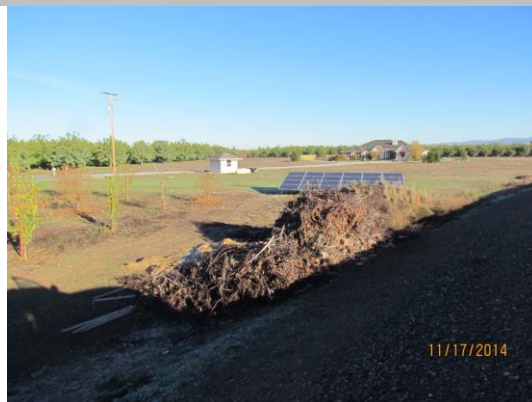
Photo 1 of 1 : FA_2019_NA0003_64_27_20190822_00008.jpg

LM Start	3.25	Rating **	M	Issue No.	27
LM End	3.25	Issue Type +	En	Location *	LS
Category	Earthen Levee			GPS Latitude/Longitude	
				Start	End
Item	Encroachments			39.763993 °	39.763993 °
				-121.909108 °	-121.909108 °
DWR ID	DWR_NA0003_01_f_2014_27				
Comment Code					
PR : Prunings					
Inspector Comment					
Remove the prunings from the landside slope.

View of the prunings along the landside toe.

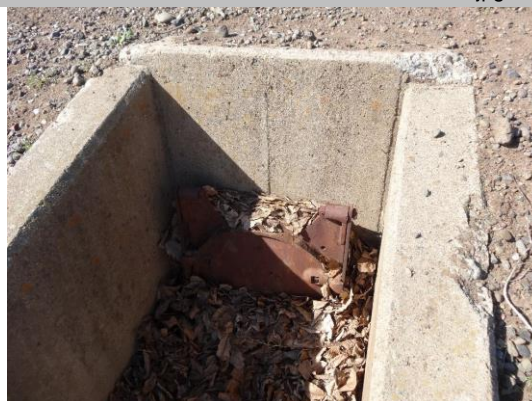
Photo 1 of 3 : UCIP_FA_2019_30310_55741.jpg

WS view: U type concrete headwall, pipe, and flapgate on levee slope. Vegetation debris blocking outlet.

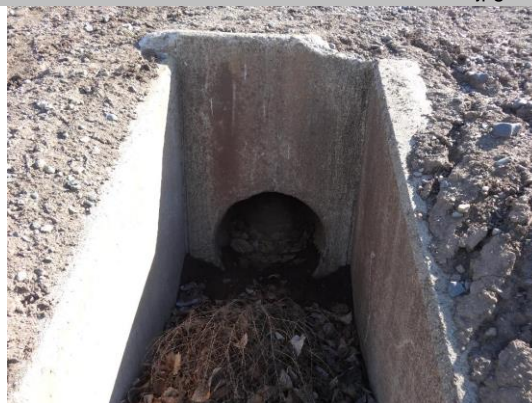
Photo 2 of 3 : UCIP_FA_2019_30310_55740.jpg

LS view: U type concrete headwall and CMP on levee slope.

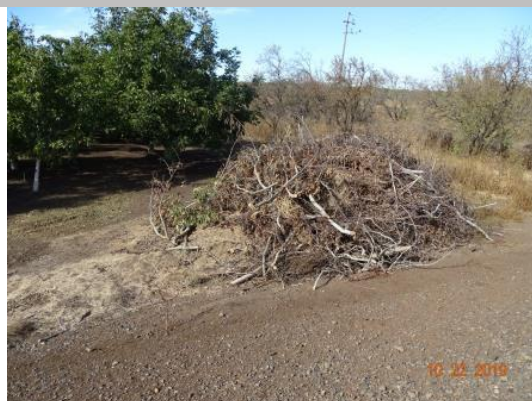
Photo 1 of 1 : FA_2019_NA0003_64_23_20191025_00056.jpg

LM Start	3.70	Rating **	M	Issue No.	23
LM End	3.70	Issue Type +	En	Location *	LS
Category	Earthen Levee			GPS Latitude/Longitude	
				Start	End
Item	Encroachments			39.767876 °	39.767876 °
				-121.902545 °	-121.902545 °
DWR ID	DWR_NA0003_01_f_2019_23				
Comment Code					
PR : Prunings					
Inspector Comment					
Pile of prunings should be removed from the landside toe easement.

View of the pile of prunings at the landside toe. Fall 2019.

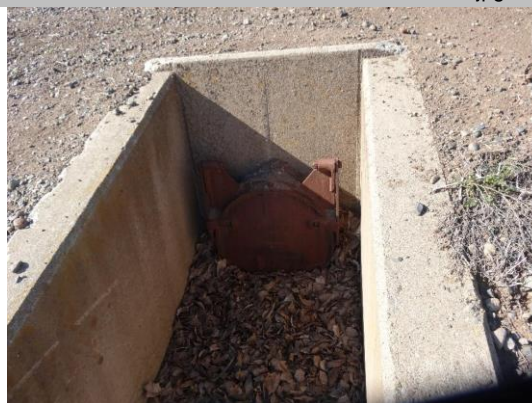
Photo 1 of 2 : UCIP_FA_2019_30311_55743.jpg

Comment Code						
Inspector Comment						
DS_ID:19219						
FS_ID:30311						
EP_NO: N/A						
Repair Type: Non-Urgent						
Crossing Status: Found						
UCIP Comments: Needs cleaning and clearing of debris in both ends of the pipe.						
FIELD_STRUCT_DESC: 24-inch corrugated metal gravity drainage pipe through the levee, 9 feet below the crown. Flap gate on the waterside (WS) end. Concrete U-shaped headwall on each end. Grouted riprap apron on the landside (LS) end. Grouted riprap spillway on the WS end. [Additional Reference(s): DWR Levee Log, 1992. USACE Sacramento O&M Manual 504, May 1965, (HLM 4.08)].						
FS Date: 2/20/2014

WS view: U type concrete headwall, pipe, and flapgate on levee slope. Vegetation debris blocking outlet.

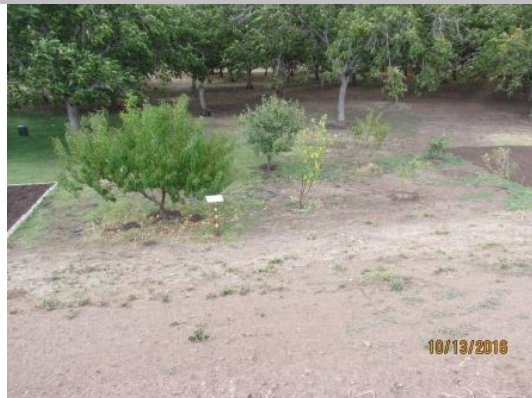
Photo 1 of 1 : FA_2019_NA0003_64_29_20190822_00009.jpg

LM Start	4.01	Rating **	U	Issue No.	29
LM End	4.01	Issue Type +	En	Location *	LS
Category	Earthen Levee			GPS Latitude/Longitude	
				Start	End
Item	Encroachments			39.771732 °	39.771732 °
				-121.899699 °	-121.899699 °
DWR ID	DWR_NA0003_01_f_2014_29				
Comment Code					
CR : Crops					
Inspector Comment					
Fruit trees are present at the toe of the levee.

View of the fruit trees within 10' of landside levee toe.

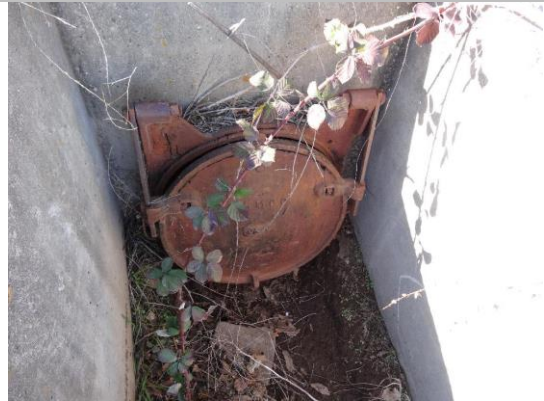
Photo 1 of 2 : UCIP_FA_2019_30312_55745.jpg

WS view: U type concrete headwall, pipe, and flapgate on levee slope. Vegetation debris blocking outlet.

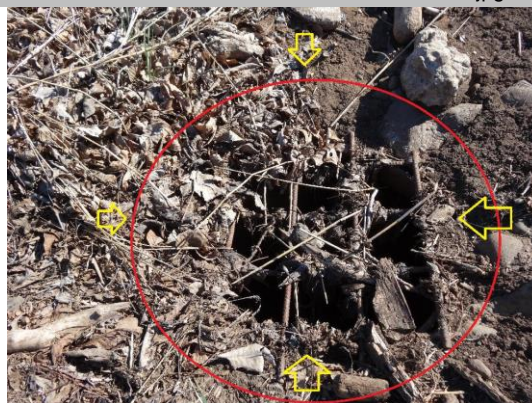
Photo 2 of 2 : UCIP_FA_2019_30388_55890.jpg

Comment Code						
Inspector Comment						
DS_ID:19221 FS_ID:30388 EP_NO: N/A Repair Type: Non-Urgent Crossing Status: Found UCIP Comments: CM Standpipe intake. Intake pipe with air vent. Steel rib-bar grit cover on the standpipe on landside levee toe.Needs cleaning and clearing on both ends of the pipe. FIELD_STRUCT_DESC: 24-inch corrugated metal gravity drainage pipe through the levee, 15 feet below the crown. Flap gate on the waterside (WS) end. Concrete U-shaped headwall on the WS end. Grouted riprap spillway on the WS end. Corrugated metal standpipe intake. Intake pipe with an air vent. Steel rib-bar grit cover on the standpipe on the landside (LS) toe. [Additional Reference(s): DWR Levee Log, 1992. USACE Sacramento O&M Manual 504, May 1965, (HLM 4.94)]. FS Date: 2/20/2014

LS view: Underground CM standpipe intake with steel grit on levee toe.

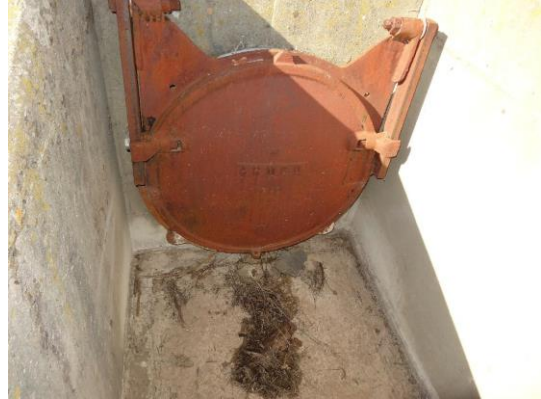
Photo 1 of 3 : UCIP_FA_2019_30327_55768.jpg

WS view: U type concrete headwall, pipe, and flapgate on levee slope.

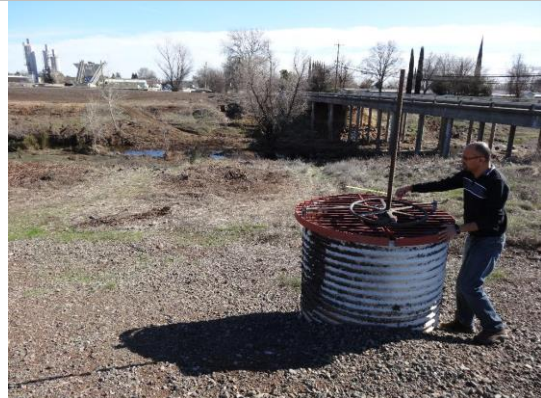
Photo 2 of 3 : UCIP_FA_2019_30327_55767.jpg

WS view: CM standpipe with slide gate on levee slope.

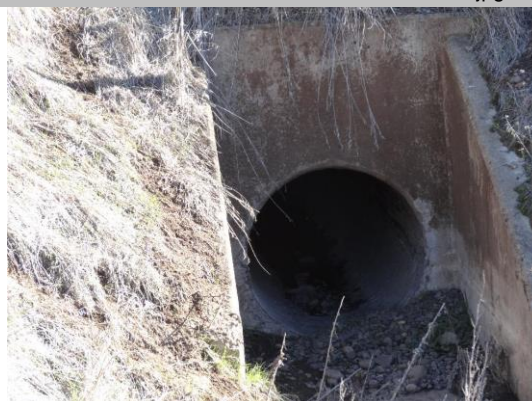
Photo 3 of 3 : UCIP_FA_2019_30327_55766.jpg

Comment Code					
Inspector Comment					
DS_ID:19222					
FS_ID:30327					
EP_NO: N/A					
Repair Type: No Action Needed					
Crossing Status: Found					
UCIP Comments: Slide gate in CM stadpipe on waterside levee slope.					
FIELD_STRUCT_DESC: 36-inch corrugated metal gravity drainage pipe					
through the levee, 17 feet below the crown. Slide gate in a corrugated					
metal standpipe on the waterside (WS) slope. Flap gate on the WS					
end. Concrete U-shaped headwall on each end. Grouted riprap apron					
on the landside (LS) end. Grouted riprap spillway on the WS end.					
[Additional Reference(s): DWR Levee Log, 1992. USACE Sacramento					
O&M Manual 504, May 1965, (HLM 5.22)].					
FS Date: 2/20/2014

LS view: U type concrete headwall and CMP on levee slope.

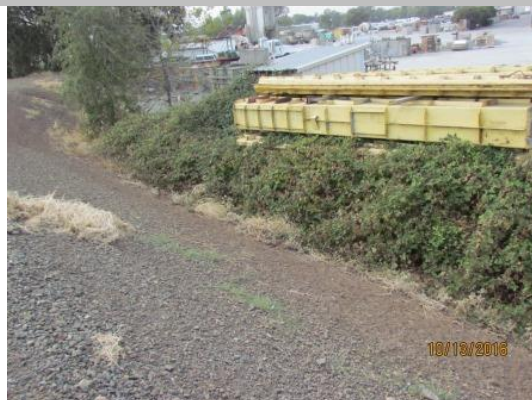
Photo 1 of 1 : FA_2019_NA0003_64_55_20190822_00023.jpg

LM Start	5.20	Rating **	M	Issue No.	55
LM End	5.20	Issue Type +	Ma	Location *	LS
Category	Earthen Levee			GPS Latitude/Longitude	
				Start	End
Item	Vegetation			39.784234 °	39.784234 °
				-121.886589 °	-121.886589 °
DWR ID	DWR_NA0003_01_f_2016_55				
Comment Code					
V2 : Remove the wild growth other than native grasses from the levee slopes.					
Inspector Comment

View of the blackberries blocking visibility and access.

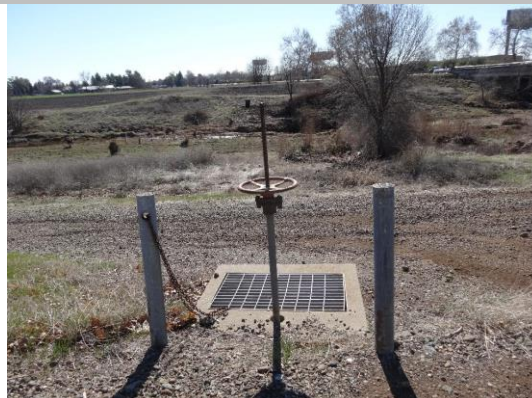
Photo 1 of 3 : UCIP_FA_2019_30368_55861.jpg

LM Start	5.30	Rating **	M	Issue No.	76	
LM End	5.30	Issue Type +	En	Location *		
Category	Supplemental			GPS Latitude/Longitude		
				Start	End	
Item	DRAFT DWR UCIP Field Study			39.784739 °	39.784739 °	
				-121.884860 °	-121.884860 °	
DWR ID	19223					
Comment Code						
Inspector Comment						
DS_ID:19223 FS_ID:30368 EP_NO: N/A Repair Type: Non-Urgent Crossing Status: Found UCIP Comments: 12-inch steel pipe about 14 ft below the crown. FIELD_STRUCT_DESC: 12-inch steel drainage discharge pipeline through the levee, 14 feet below the crown. Slide gate in a concrete box on the waterside (WS) slope. Flap gate on the WS end. Grouted rock revetment on the WS slope. Three pumps on a concrete pad on the landside (LS). [Additional Reference(s): DWR Levee Log, 1992, 18-inch pipe referenced, 1 foot below the crown]. FS Date: 2/24/2014

WS view: slide gate in concrete box on levee slope.

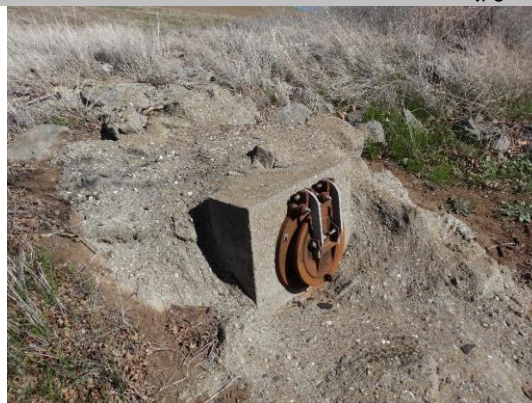
Photo 2 of 3 : UCIP_FA_2019_30368_55860.jpg

WS view: concrete headwall and flapgate on levee slope.

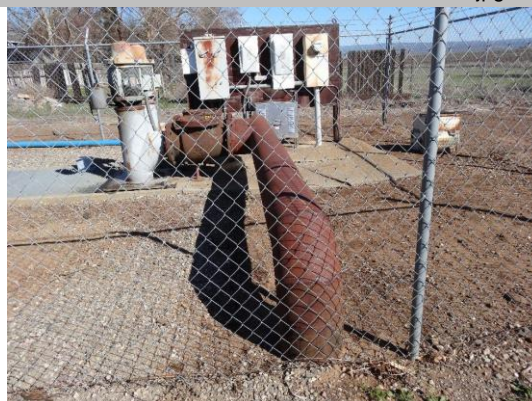
Photo 3 of 3 : UCIP_FA_2019_30368_55859.jpg

LM Start	5.30	Rating **	M	Issue No.	76 (cont)	
LM End	5.30	Issue Type +	En	Location *		
Category	Supplemental			GPS Latitude/Longitude		
				Start	End	
Item	DRAFT DWR UCIP Field Study			39.784739 °	39.784739 °	
				-121.884860 °	-121.884860 °	
DWR ID	19223					
Comment Code						
Inspector Comment						
DS_ID:19223 FS_ID:30368 EP_NO: N/A Repair Type: Non-Urgent Crossing Status: Found UCIP Comments: 12-inch steel pipe about 14 ft below the crown. FIELD_STRUCT_DESC: 12-inch steel drainage discharge pipeline through the levee, 14 feet below the crown. Slide gate in a concrete box on the waterside (WS) slope. Flap gate on the WS end. Grouted rock revetment on the WS slope. Three pumps on a concrete pad on the landside (LS). [Additional Reference(s): DWR Levee Log, 1992, 18-inch pipe referenced, 1 foot below the crown]. FS Date: 2/24/2014

LS view: pipe, pumps, power boxes, concrete vault on landside.

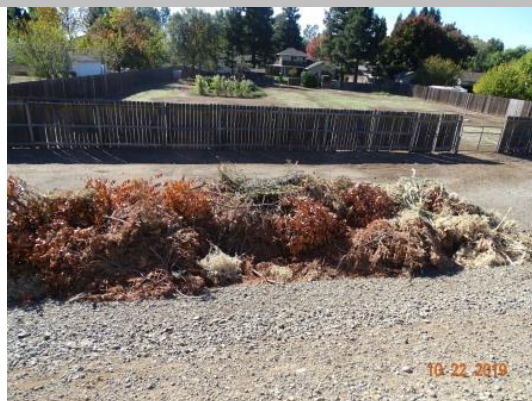
Photo 1 of 1 : FA_2019_NA0003_64_35_20191025_00057.jpg

LM Start	5.65	Rating **	M	Issue No.	35
LM End	5.65	Issue Type +	Ma	Location *	LS
Category	Earthen Levee			GPS Latitude/Longitude	
				Start	End
Item	Encroachments			39.789093 °	39.789093 °
				-121.886500 °	-121.886500 °
DWR ID	DWR_NA0003_01_f_2019_35				
Comment Code					
PR : Prunings					
Inspector Comment					
The pile of prunings should be removed from the landside toe easement.

View of the pile of prunings at the landside toe. Fall 2019.

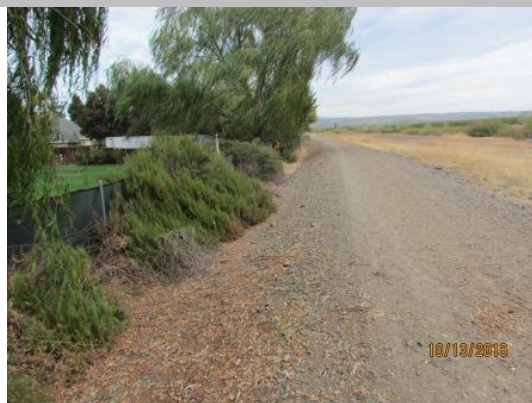
Photo 1 of 1 : FA_2019_NA0003_64_30_20190822_00010.jpg

LM Start	6.36	Rating **	M	Issue No.	30
LM End	6.39	Issue Type +	En	Location *	LS
Category	Earthen Levee			GPS Latitude/Longitude	
				Start	End
Item	Vegetation			39.797714 °	39.797884 °
				-121.883384 °	-121.882883 °
DWR ID	DWR_NA0003_01_s_2016_30				
Comment Code					
V6 : Landscaping					
Inspector Comment					
Rosemary landscaping covering landside toe.

View of the landscaping blocking visibility.

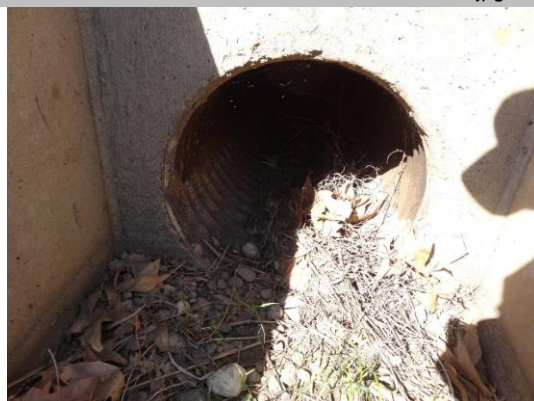
Photo 2 of 3 : UCIP_FA_2019_30403_55921.jpg

LM Start	1.26	Rating **	M	Issue No.	48 (cont)	
LM End	1.26	Issue Type +	Ma	Location *		
Category	Supplemental			GPS Latitude/Longitude		
				Start	End	
Item	DRAFT DWR UCIP LMA Responsibility			39.784062 °	39.784062 °	
				-121.884344 °	-121.884344 °	
DWR ID	19235					
Comment Code						
Inspector Comment						
DS_ID:19235 FS_ID:30403 EP_NO: N/A Repair Type: Non-Urgent Crossing Status: Found UCIP Comments: Needs cleaning and clearing of debris. FIELD_STRUCT_DESC: 24-inch corrugated metal gravity drainage pipe through the levee, 12.5 feet below the crown. Flap gate on the waterside (WS) end. Concrete U-shaped headwall on each end. Grouted riprap apron on the landside (LS) end. Grouted riprap spillway on the WS end. [Additional Reference(s): DWR Levee Log, 1992. USACE Sacramento O&M Manual 504, May 1965, (HLM 1.34)]. FS Date: 2/24/2014

LS view: U type concrete headwall and CMP on levee slope. Vegetation debris in inlet pipe.

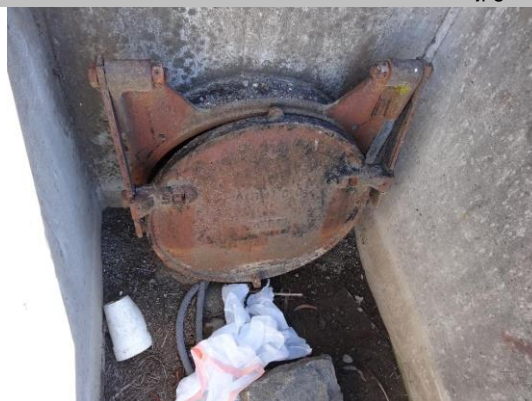
Photo 1 of 2 : UCIP_FA_2019_30743_56641.jpg

LM Start	1.46	Rating **	M	Issue No.	49	
LM End	1.46	Issue Type +	Ma	Location *		
Category	Supplemental			GPS Latitude/Longitude		
				Start		End
Item	DRAFT DWR UCIP LMA Responsibility			39.782980 °		39.782980 °
				-121.887834 °		-121.887834 °
DWR ID	19237					
Comment Code						
Inspector Comment						
DS_ID:19237 FS_ID:30743 EP_NO: N/A Repair Type: Non-Urgent Crossing Status: Found UCIP Comments: Needs cleaning and clearing of debris. FIELD_STRUCT_DESC: 24-inch corrugated metal gravity drainage pipe through the levee, 11 feet below the crown. Flap gate on the waterside (WS) end. Concrete U-shaped headwall on each end. Grouted riprap apron on the landside (LS) end. Grouted riprap spillway on the WS end. [Additional Reference(s): DWR Levee Log, 1992. USACE Sacramento O&M Manual 504, May 1965, (HLM 1.55)]. FS Date: 2/24/2014

WS view: U type concrete headwall, pipe, and flapgate on levee slope.
Debris in outlet box.

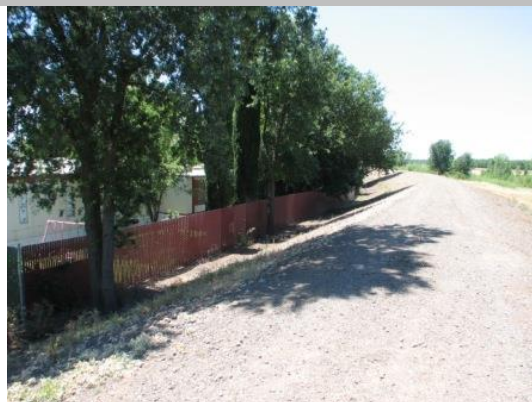
Photo 1 of 1 : FA_2019_NA0003_65_3_20190822_00002.jpg

LM Start	1.49	Rating **	U	Issue No.	3
LM End	1.81	Issue Type +	En	Location *	LS
Category	Earthen Levee			GPS Latitude/Longitude	
				Start	End
Item	Encroachments			39.782773 °	39.778972 °
				-121.888178 °	-121.891563 °
DWR ID	DWR_NA0003_02_s_2012_3				
Comment Code					
FE : Fence					
Inspector Comment

View of the fence along the landside toe of the levee.

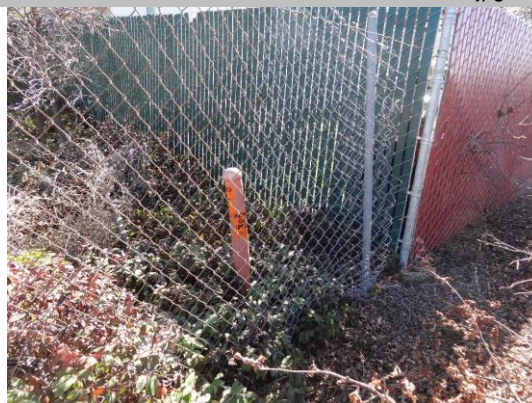
Photo 1 of 1 : UCIP_FA_2019_41873_56643.jpg

LM Start	1.49	Rating **	M	Issue No.	50	
LM End	1.49	Issue Type +	En	Location *		
Category	Supplemental			GPS Latitude/Longitude		
				Start	End	
Item	DRAFT DWR UCIP Field Study			39.782766 °	39.782766 °	
				-121.888187 °	-121.888187 °	
DWR ID	24803					
Comment Code						
Inspector Comment						
DS_ID:24803 FS_ID:41873 EP_NO: 9874 Repair Type: Non-Urgent Crossing Status: Indicator Found UCIP Comments: May need to contact owner to determine status of crossing and install markers as appropriate. FIELD_STRUCT_DESC: 6-inch natural gas main of an unknown material through both levees and under Mud Creek, downstream from the Esplanade, at an unknown depth. Indicator on the landside (LS) toe. (Plans to install a 6-inch natural gas pipeline across Mud Creek and through adjacent levee authorized under Permit No. 9874, 1974 - Pacific Gas and Electric Company [PG&E]). FS Date: 2/24/2014

LS view: gasline marker on levee toe.

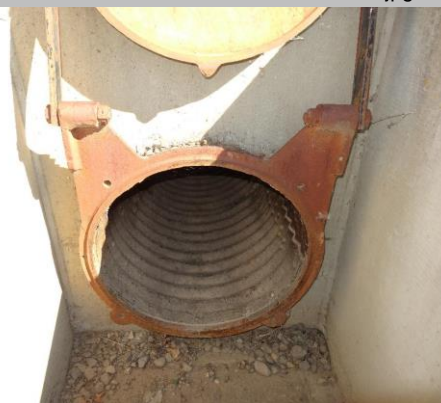
Photo 2 of 3 : UCIP_FA_2019_41375_56645.jpg

Comment Code						
Inspector Comment						
DS_ID:19238 FS_ID:41375 EP_NO: 12619A Repair Type: Non-Urgent Crossing Status: Found UCIP Comments: - 24-inch CM pipe.- inlet and spillway may need cleaning and clearing. FIELD_STRUCT_DESC: 24-inch corrugated metal gravity storm drainage pipe through the levee, 11 feet below the crown. Flap gate on the waterside (WS) end. Concrete U-shaped headwall on each end. Grouted riprap apron on the landside (LS) end. Grouted riprap spillway on the WS end. (Plans to replace an existing 24-inch storm drain inlet to the Mud Creek Diversion Channel with a 36-inch storm drain located approximately 500 feet upstream from Nord Highway authorized under Permit No. 12619, 1979 - Richard E. Vermillion. Plans for extension of time to replace an existing 24-inch storm drain inlet to the Mud Creek Diversion Channel with a 36-inch storm drain located upstream from Nord Highway authorized under Permit No. 12619-A, 1980 - Richard E. Vermillion). The storm drain never got replaced. [Additional Reference(s): DWR Levee Log, 1992, 36-inch pipe referenced. USACE Sacramento O&M Manual 504, May 1965, (HLM 2.13)]. FS Date: 2/24/2014

WS view: U type concrete headwall, pipe, and flapgate on levee slope.

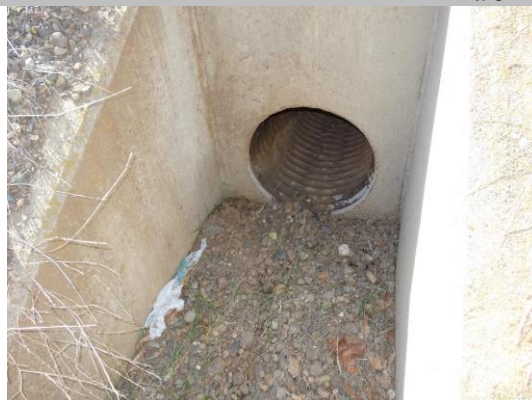
Photo 3 of 3 : UCIP_FA_2019_41375_56644.jpg

LS view: U type concrete headwall and CMP on levee slope.

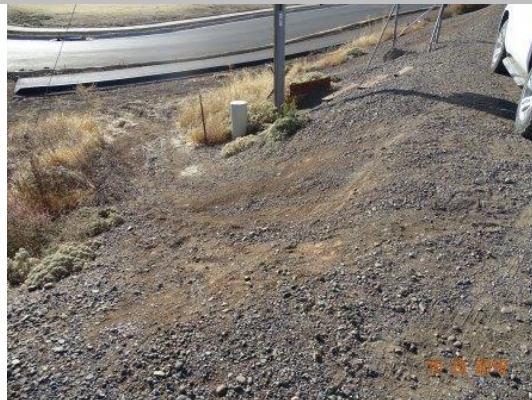
Photo 1 of 1 : FA_2019_NA0003_65_25_20191025_00064.jpg

LM Start	2.05	Rating **	M	Issue No.	25
LM End	2.05	Issue Type +	Ma	Location *	LS
Category	Earthen Levee			GPS Latitude/Longitude	
				Start	End
Item	Slope Stability			39.775748 °	39.775748 °
				-121.892958 °	-121.892958 °
DWR ID	DWR_NA0003_02_f_2019_25				
Comment Code					
S3 : Repair the levee slope damaged by vehicle traffic and prevent access where possible.					
Inspector Comment

View of the erosion on the landside slope due to vehicle traffic. Fall 2019.

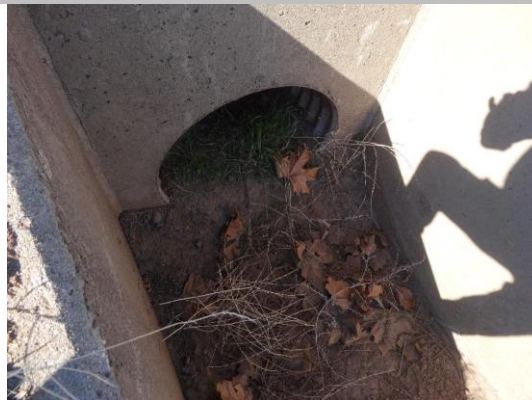
Photo 2 of 3 : UCIP_FA_2019_30763_56661.jpg

Comment Code						
Inspector Comment						
DS_ID:19239						
FS_ID:30763						
EP_NO: N/A						
Repair Type: Non-Urgent						
Crossing Status: Found						
UCIP Comments: Debris in landside inlet area. Needs cleaning and clearing of debris.						
FIELD_STRUCT_DESC: 24-inch corrugated metal gravity drainage pipe through the levee, 10 feet below the crown. Flap gate on the waterside (WS) end. Concrete U-shaped headwall on each end. Grouted riprap apron on the landside (LS) end. Grouted riprap spillway on the WS end. [Additional Reference(s): DWR Levee Log, 1992. USACE Sacramento O&M Manual 504, May 1965, (HLM 2.44)].						
FS Date: 2/24/2014

LS view: U type concrete headwall and CMP on levee slope.

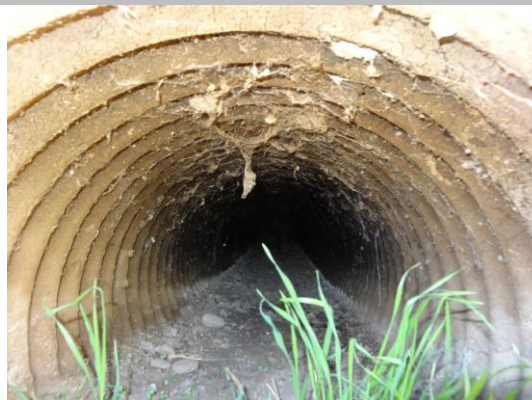
Photo 3 of 3 : UCIP_FA_2019_30763_56660.jpg

LS view: inside view of CMP on levee slope. Needs cleaning and clearing.

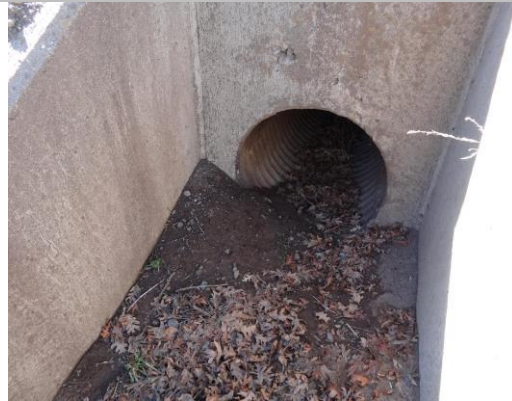
Photo 2 of 3 : UCIP_FA_2019_30783_56681.jpg

LM Start	2.74	Rating **	M	Issue No.	53 (cont)
LM End	2.74	Issue Type +	Ma	Location *	
Category	Supplemental			GPS Latitude/Longitude	
				Start	End
Item	DRAFT DWR UCIP LMA Responsibility			39.768741 °	39.768741 °
				-121.901176 °	-121.901176 °
DWR ID	19240				
Comment Code					
Inspector Comment					
DS_ID:19240 FS_ID:30783 EP_NO: N/A Repair Type: Non-Urgent Crossing Status: Found UCIP Comments: Needs cleaning and clearing of debris. FIELD_STRUCT_DESC: 24-inch corrugated metal gravity drainage pipe through the levee, 10 feet below the crown. Flap gate on the waterside (WS) end. Concrete U-shaped headwall on each end. Grouted riprap apron on the landside (LS) end. Grouted riprap spillway on the WS end. [Additional Reference(s): DWR Levee Log, 1992. USACE Sacramento O&M Manual 504, May 1965, (HLM 2.86)]. FS Date: 2/24/2014

LS view: U type concrete headwall and CMP on levee slope. Debris and soil in inlet box.

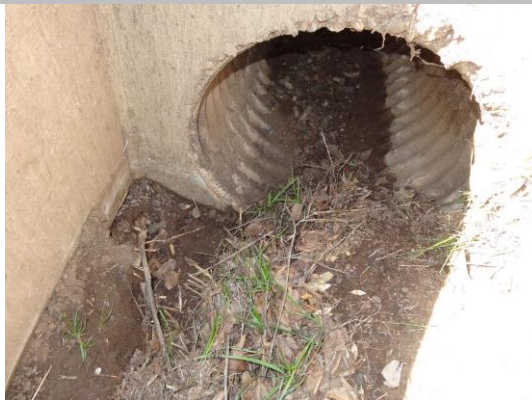
Photo 2 of 3 : UCIP_FA_2019_31028_56912.jpg

LM Start	4.61	Rating **	M	Issue No.	55 (cont)	
LM End	4.61	Issue Type +	Ma	Location *		
Category	Supplemental			GPS Latitude/Longitude		
				Start		End
Item	DRAFT DWR UCIP LMA Responsibility			39.748731 °		39.748731 °
				-121.917577 °		-121.917577 °
DWR ID	19245					
Comment Code						
Inspector Comment						
DS_ID:19245 FS_ID:31028 EP_NO: N/A Repair Type: Non-Urgent Crossing Status: Found UCIP Comments: Needs cleaning and clearing of debris. FIELD_STRUCT_DESC: 24-inch corrugated metal gravity drainage pipe through the levee, 10 feet below the crown. Flap gate on the waterside (WS) end. Concrete U-shaped headwall on each end. Grouted riprap apron on the landside (LS) end. Grouted riprap spillway on the WS end. [Additional Reference(s): DWR Levee Log, 1992. USACE Sacramento O&M Manual 504, May 1965, (HLM 4.77)]. FS Date: 2/25/2014

LS view: U type concrete headwall and CMP on levee slope.

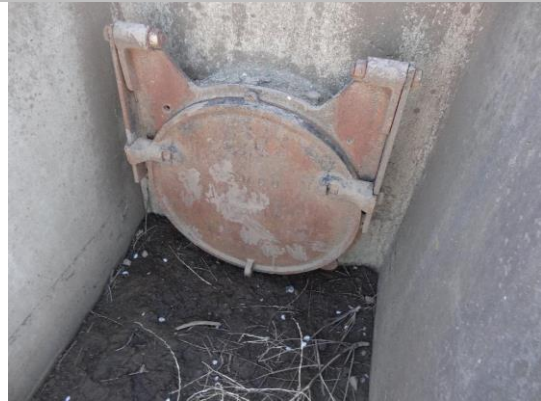
Photo 1 of 3 : UCIP_FA_2019_31031_56917.jpg

WS view: U type concrete headwall, pipe, and flapgate on levee slope. Soil/mud on outlet box.

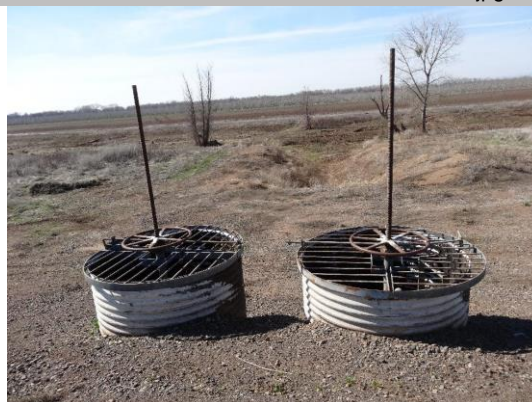
Photo 1 of 3 : UCIP_FA_2019_41376_56920.jpg

Comment Code					
Inspector Comment					
DS_ID:19248 FS_ID:41376 EP_NO: N/A Repair Type: Non-Urgent Crossing Status: Found UCIP Comments: Needs cleaning and clearing of debris. FIELD_STRUCT_DESC: [Channel Slough Drainage Structure] 1 of 2: 42-inch corrugated metal gravity drainage pipe through the levee, 16 feet below the crown. Flap gate on the waterside (WS) end. Slide gate in a corrugated metal pipe (CMP) riser on the WS slope. Concrete U-shaped headwall on each end. Grouted riprap apron and rock revetment on the landside (LS) end. [Additional Reference(s): DWR Levee Log, 1992. USACE Sacramento O&M Manual 504, May 1965, (HLM 6.30)]. FS Date: 2/25/2014

WS view: slide gates in CMP risers on levee slope.

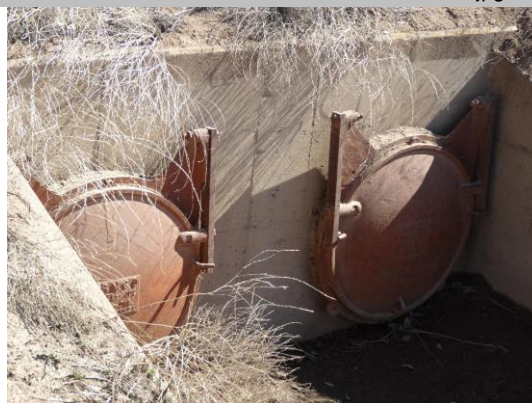
Photo 2 of 3 : UCIP_FA_2019_41376_56919.jpg

WS view: U type concrete headwall, pipes, and flapgates on levee slope. Vegetation debris on outlet box.

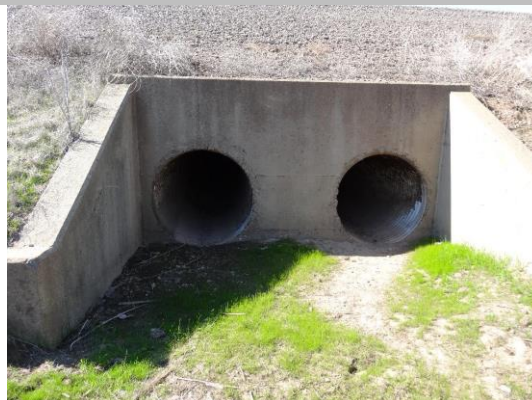
Photo 3 of 3 : UCIP_FA_2019_41376_56918.jpg

LS view: U type concrete headwall and CMPs on levee slope. Soil/mud on inlet box.

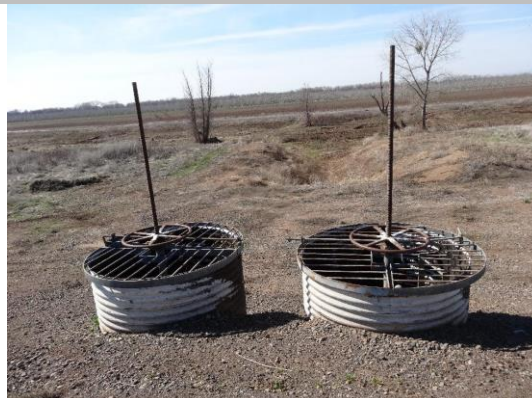
Photo 1 of 3 : UCIP_FA_2019_41377_56923.jpg

WS view: slide gates in CMP risers on levee slope.

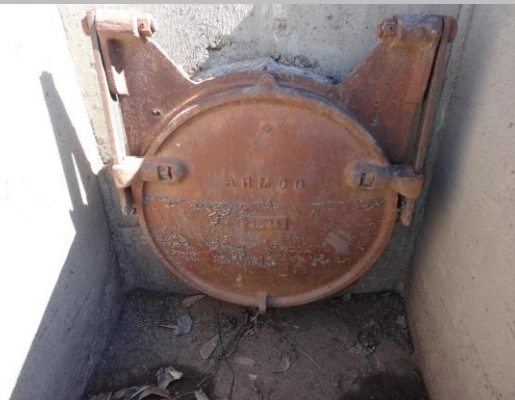
Photo 1 of 3 : UCIP_FA_2019_31034_56926.jpg

WS view: U type concrete headwall, pipe, and flapgate on levee slope.

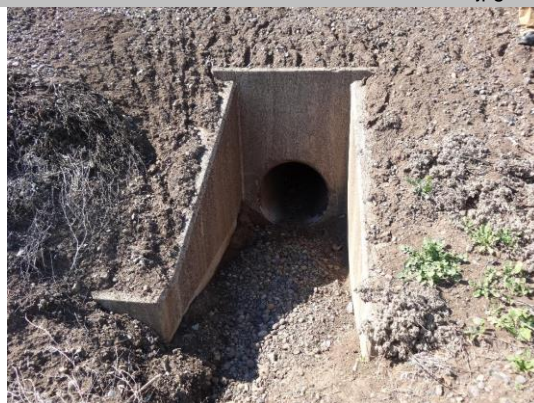
Photo 2 of 3 : UCIP_FA_2019_31034_56925.jpg

LS view: U type concrete headwall and CMP on levee slope.

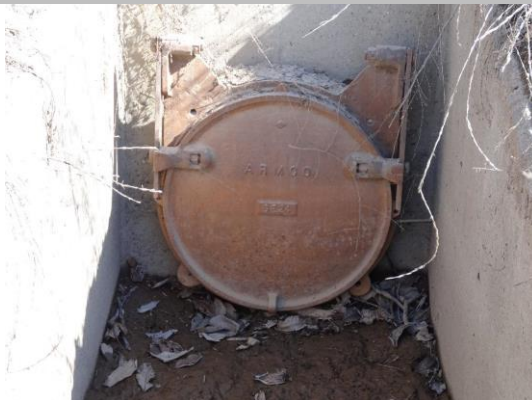
Photo 1 of 3 : UCIP_FA_2019_31085_56988.jpg

WS view: U type concrete headwall, pipe, and flapgate on levee slope.
Soil/mud on outlet box.

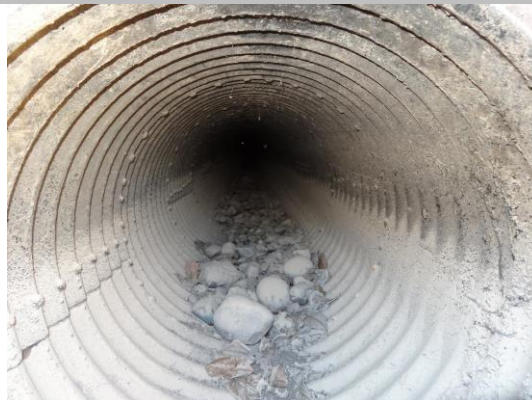
Photo 3 of 3 : UCIP_FA_2019_31085_56986.jpg

LS view: inside view of CMP on levee slope. Needs cleaning and clearing.

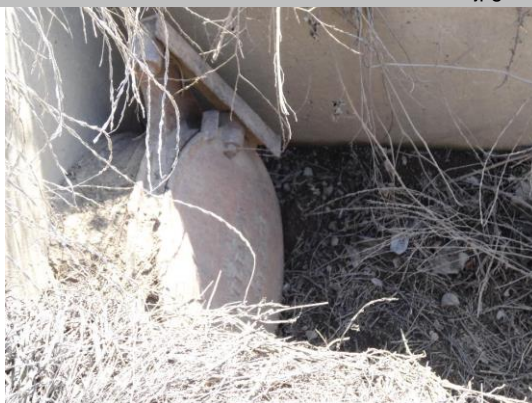
Photo 1 of 3 : UCIP_FA_2019_31103_57002.jpg

WS view: U type concrete headwall, pipe, and flapgate on levee slope. Soil/mud on outlet box. Vegetation debris blocking outlet box

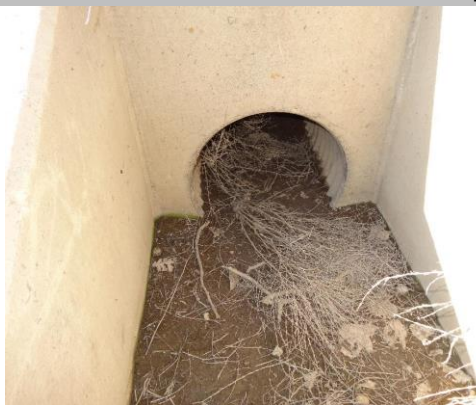
Photo 2 of 3 : UCIP_FA_2019_31103_57001.jpg

LS view: U type concrete headwall and CMP on levee slope. Soil/mud on inlet box.

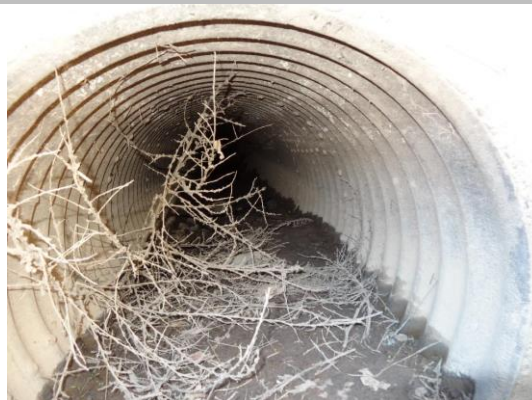
Photo 3 of 3 : UCIP_FA_2019_31103_57000.jpg

LS view: inside view of CMP on levee slope. Needs cleaning and clearing.

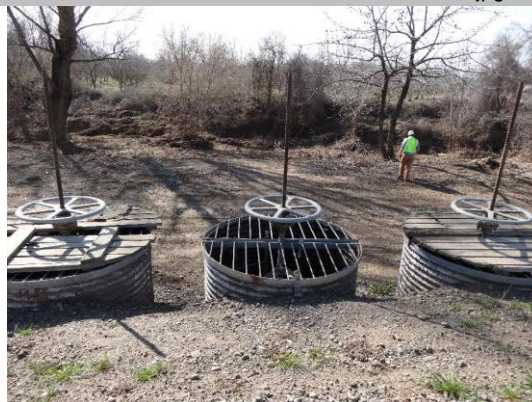
Photo 1 of 3 : UCIP_FA_2019_32085_58585.jpg

Comment Code					
Inspector Comment					
DS_ID:19253 FS_ID:32085 EP_NO: N/A Repair Type: Non-Urgent Crossing Status: Found UCIP Comments: Slide gates in CMP risers on waterside shoulder.Needs cleaning and clearing of debris. FIELD_STRUCT_DESC: 1 of 3: 48-inch corrugated metal gravity drainage pipe through the levee, 18 feet below the crown. Flap gate on the waterside (WS) end. Slide gate in a corrugated metal pipe (CMP) riser on the WS shoulder. Concrete U-shaped headwall on each end. Grouted riprap apron on the landside (LS) end. Grouted riprap spillway on the WS end. [Additional Reference(s): DWR Levee Log, 1992. USACE Sacramento O&M Manual 504, May 1965, (HLM 7.46)]. FS Date: 2/25/2014

WS view: slide gates in CMP risers on waterside shoulder.

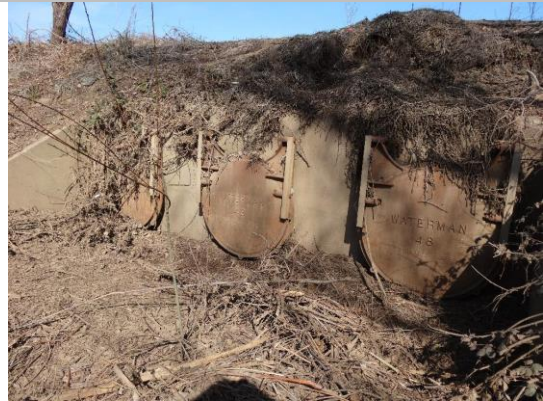
Photo 2 of 3 : UCIP_FA_2019_32085_58584.jpg

WS view: U type concrete headwall, pipes, and flapgates on levee slope.
Soil/mud on outlet box. Vegetation debris blocking outlet box

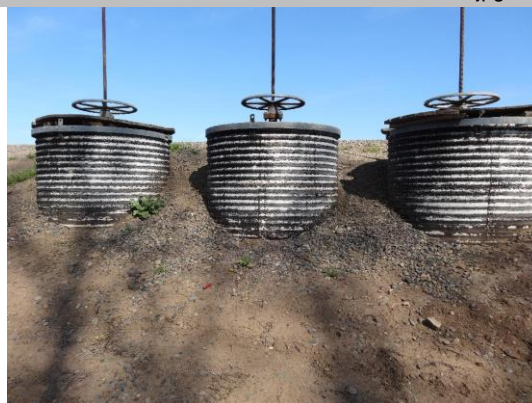
Photo 1 of 3 : UCIP_FA_2019_32087_58592.jpg

Comment Code						
Inspector Comment						
DS_ID:19261 FS_ID:32087 EP_NO: N/A Repair Type: Non-Urgent Crossing Status: Found UCIP Comments: Slide gates in CMP risers on waterside shoulder.Needs cleaning and clearing on both pipe ends. FIELD_STRUCT_DESC: 3 of 3: 48-inch corrugated metal gravity drainage pipe through the levee, 18 feet below the crown. Flap gate on the waterside (WS) end. Slide gate in a corrugated metal pipe (CMP) riser on the WS shoulder. Concrete U-shaped headwall on each end. Grouted riprap apron on the landside (LS) end. Grouted riprap spillway on the WS end. [Additional Reference(s): DWR Levee Log, 1992. USACE Sacramento O&M Manual 504, May 1965, (HLM 7.46)]. FS Date: 2/25/2014

WS view: slide gates in CMP risers on waterside shoulder.

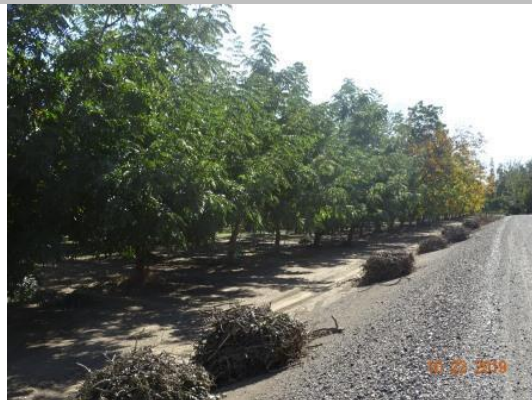
Photo 1 of 1 : FA_2019_NA0003_65_46_20191025_00065.jpg

LM Start	7.25	Rating **	M	Issue No.	46
LM End	7.89	Issue Type +	En	Location *	LS
Category	Earthen Levee			GPS Latitude/Longitude	
				Start	End
Item	Encroachments			39.718535 °	39.709884 °
				-121.937350 °	-121.935979 °
DWR ID	DWR_NA0003_02_s_2019_46				
Comment Code					
PR : Prunings					
Inspector Comment					
The prunings should be removed from the landside slope and toe.

View of the piles of prunings along the landside toe. Fall 2019.

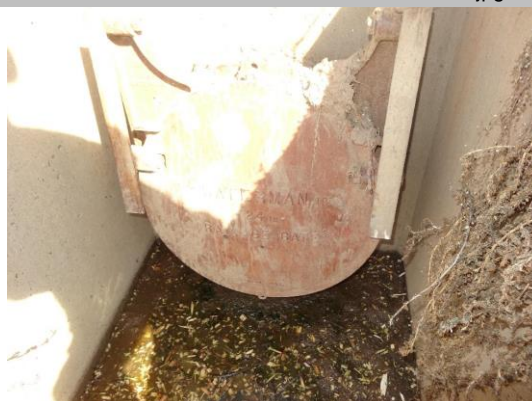
Photo 1 of 2 : UCIP_FA_2019_31129_57036.jpg

WS view: U type concrete headwall, pipe, and flapgate on levee slope. Soil/mud on outlet box.

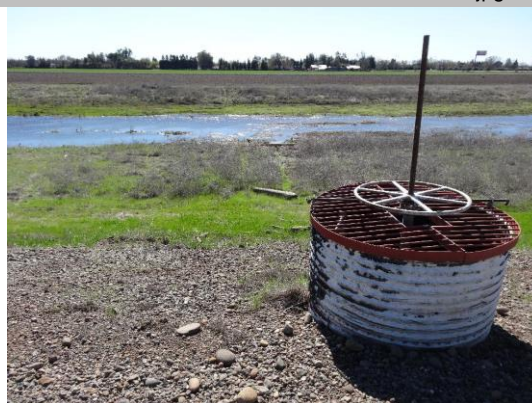
Photo 3 of 3 : UCIP_FA_2019_51844_58600.jpg

WS view: slide gate in CMP riser on waterside shoulder.

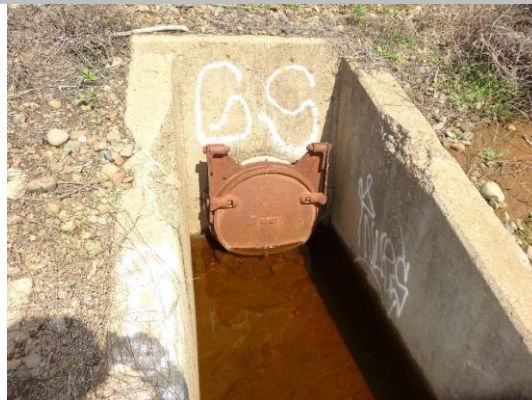
Photo 1 of 2 : UCIP_FA_2019_31899_58187.jpg

WS view: U type concrete headwall, flapgate, and CMP on levee slope. Looks clean and clear.

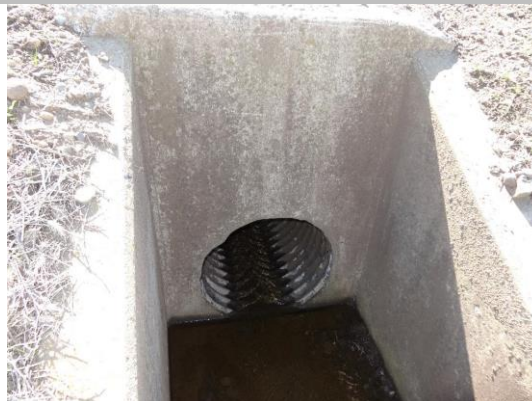
Photo 2 of 2 : UCIP_FA_2019_31899_58186.jpg

LS view: U type concrete headwall and CMP on levee slope. Looks clean and clear.

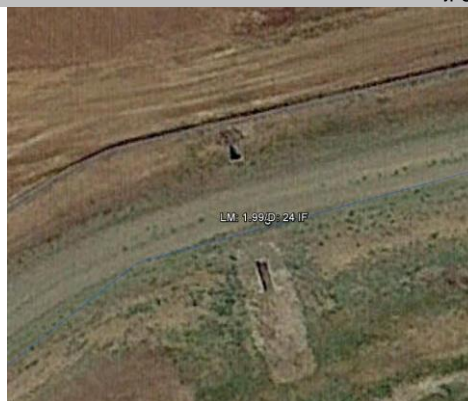
Photo 1 of 1 : UCIP_FA_2019_31900_58189.jpg

Comment Code					
Inspector Comment					
DS_ID:19266					
FS_ID:31900					
EP_NO: N/A					
Repair Type: Non-Urgent					
Crossing Status: Indicator Found					
UCIP Comments: Needs location confirmation, GPS reading has not taken due to access problem.					
FIELD_STRUCT_DESC: 24-inch corrugated metal gravity drainage pipe through the levee, 8 feet below the crown. Flap gate on the waterside (WS) end. Concrete U-shaped headwall on each end. Grouted riprap apron on the landside (LS) end. Grouted riprap spillway on the WS end. [Additional Reference(s): DWR Levee Log, 1992. USACE Sacramento O&M Manual 504, May 1965, (HLM 2.00)].					
FS Date: 3/11/2014

Bird's eye view: concrete headwall visible on both sides of the levee.
Grouted riprap spillway on waterside.

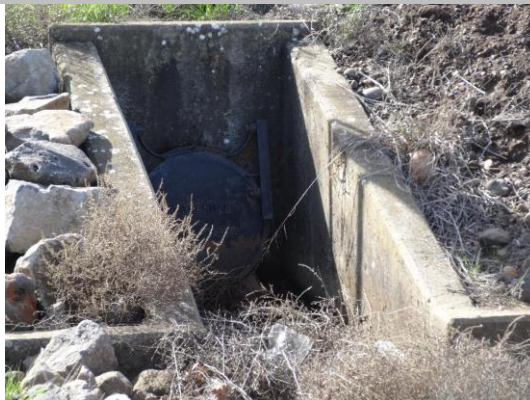
Photo 1 of 3 : UCIP_FA_2019_32124_58625.jpg

WS view: concrete headwall, pipe, and flapgate on levee slope.
Vegetation and mud on outlet box.
